Halton Region Conservation Authority (HRCA) Bridges Master Plan Class Environmental Assessment

**Public Information Centre
June 7, 2007**

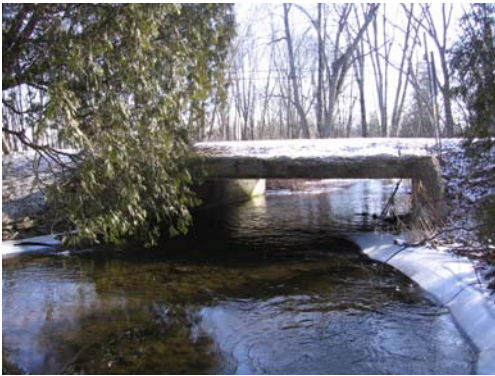
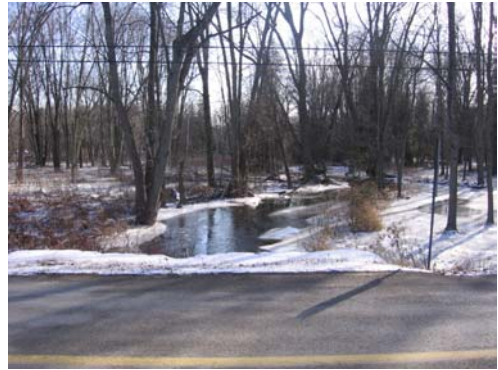
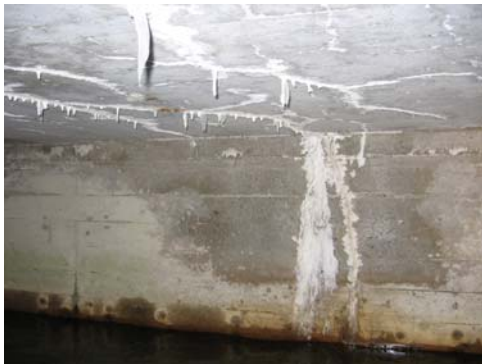
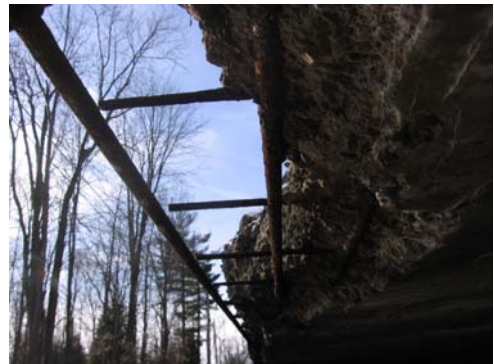
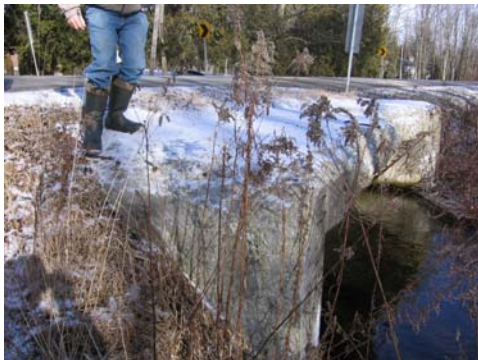
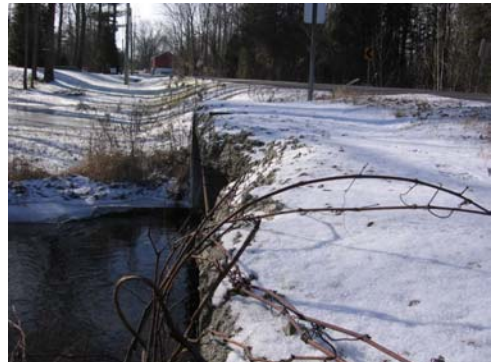
Existing Conditions

- Severe wearing of asphalt deck surface
- Severe scaling of the exposed portions (ends) of the concrete culvert top slab
- Ends of the concrete culvert top slab disintegrated up to 600 mm from ends
- Severe cracking and delaminations on the soffit of the concrete culvert top slab
- No guardrails or approach guard rails
- Substandard frost protection

- Alternative 4 – Repair Structure
- Details:
 - Replace culvert top slab
 - Repair existing culvert walls
 - Consider constructing retaining walls to facilitate widening roadway and shoulders to match approaches
 - Construct guardrails and approach guiderails

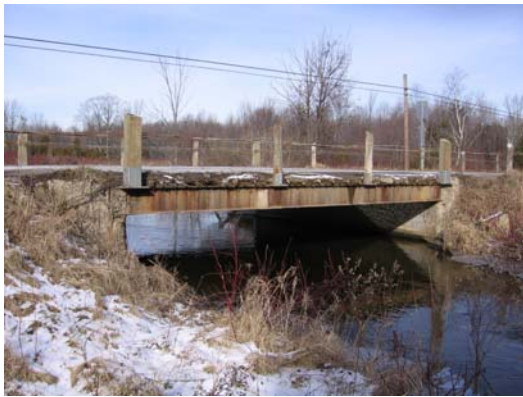
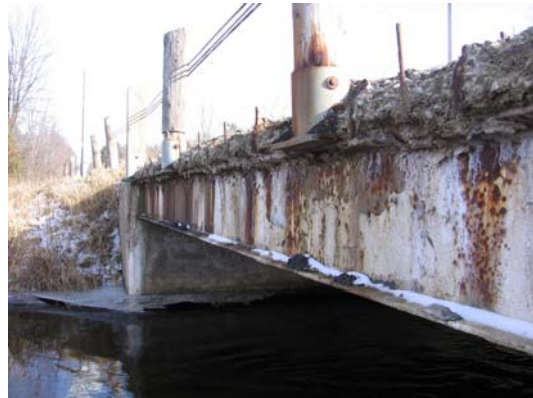
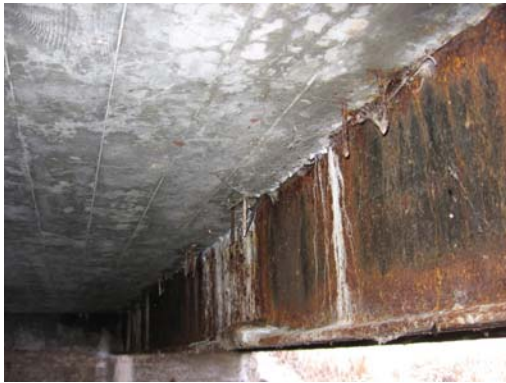
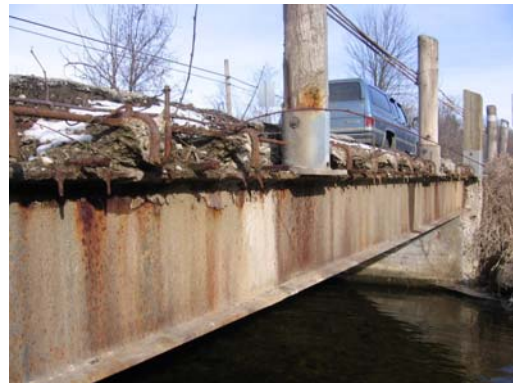
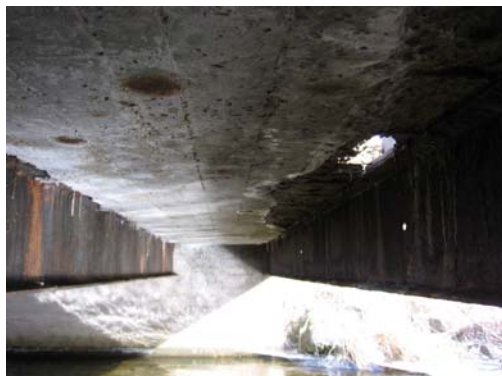
Existing Conditions

- Asphalt wearing surface in fair condition
- Coating on girders has failed and is no longer providing corrosion protection
- Original concrete curbs on deck have completely disintegrated
- Edge of concrete deck disintegrated up to 150 mm
- Substandard frost protection
- Bridge guard rails are sub-standard
- Approach guardrail in poor condition
- Severe corrosion on girder flanges, light to medium corrosion on girder webs

- Alternative 5 - Replace Structure
- Details:
 - Minimum 7.4 m by 1.2 m hydraulic opening
 - Bridge type alternatives:
 - Cast-in-place or precast concrete open footing culvert
 - Cast-in-place or precast concrete slab on steel girder (integral or semi-integral abutments)
 - Side-by-side precast, prestressed slabs with cast-in-place concrete topping (integral or semi-integral abutments)

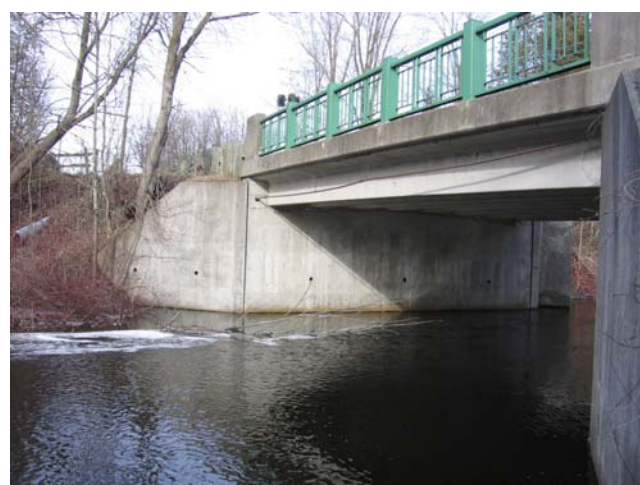
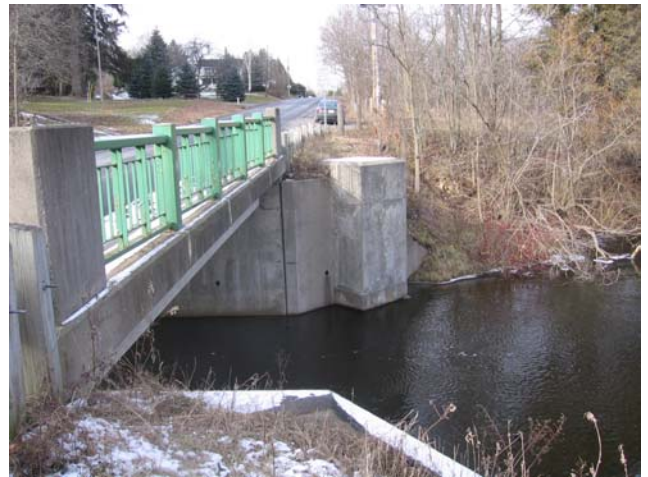
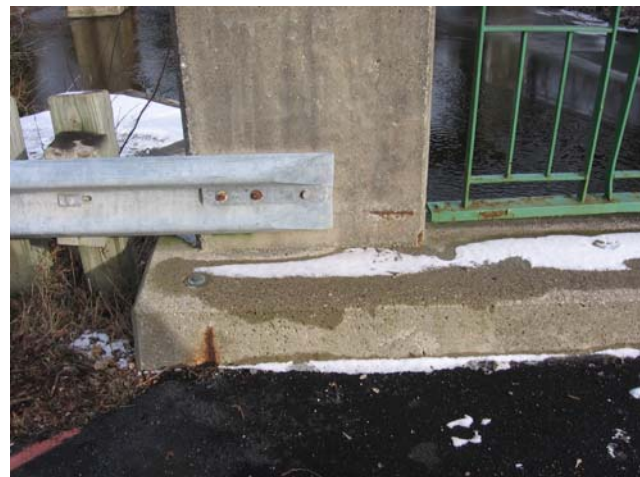
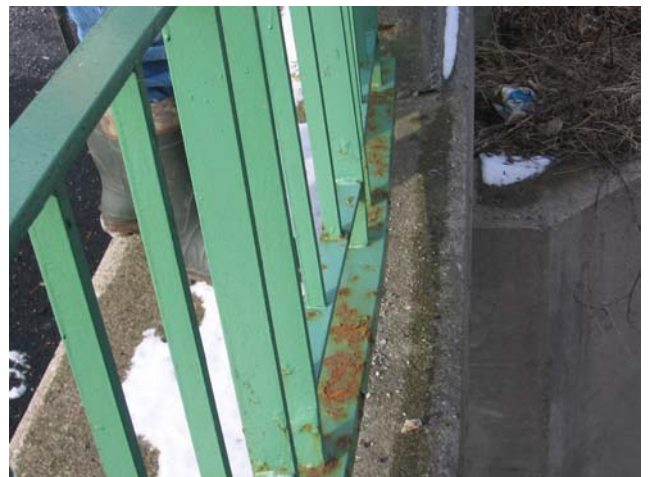
Existing Conditions

- No severe defects
- Coating on railings is starting to fail
- Light corrosion on railings

- Alternative 4 – Repair Structure
- Details:
 - Paint bridge railings

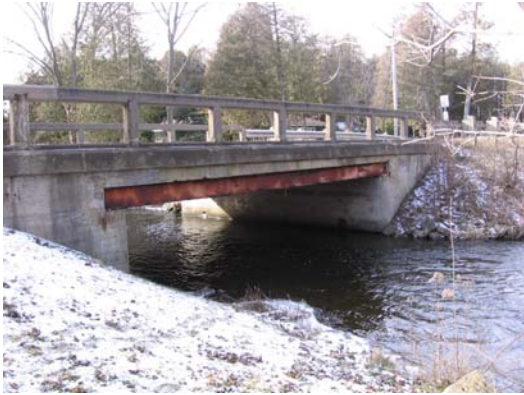
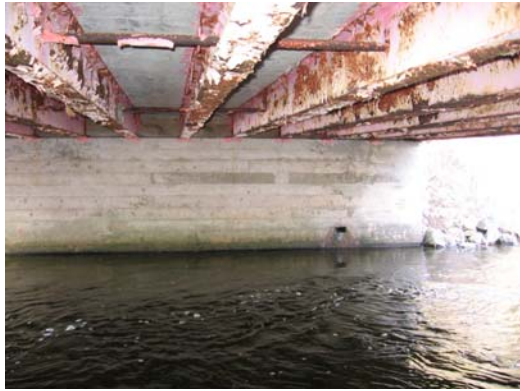
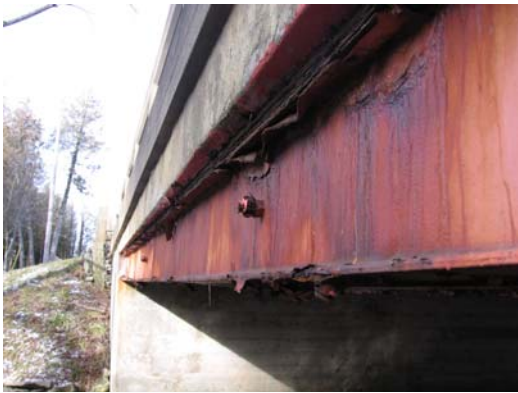
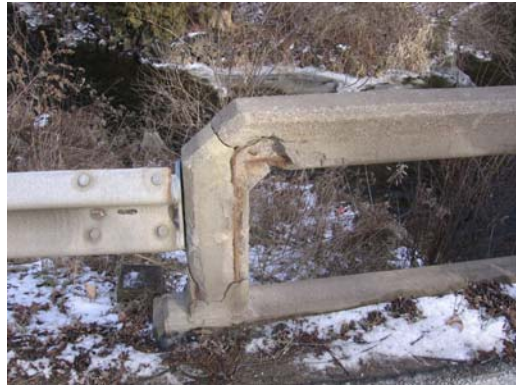
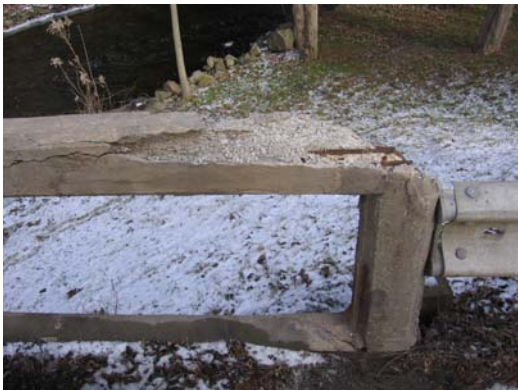
Existing Conditions

- Cracking, delamination and spalls on concrete deck soffit
- Abutments are in fair condition with areas of delamination and spalls
- Coating on steel girders has failed and is no longer providing corrosion protection
- Medium to severe corrosion on steel girders
- Sub-standard frost protection
- Bridge railings are sub-standard and are in poor condition

- Alternative 5 – Replace Structure
- Details:
 - Minimum 7.4 m by 1.8 m hydraulic opening
 - Bridge type alternatives:
 - Cast-in-place or precast concrete open footing culvert
 - Cast-in-place or precast concrete slab on steel girder (integral or semi-integral abutments)
 - Side-by-side precast, prestressed slabs with cast-in-place concrete topping (integral or semi-integral abutments)
